## Examination of returned Surveyor III surface sampler

R. F. SCOTT and K. A. ZUCKERMAN

**Abstract**—The scoop and portions of the arms of the Surveyor III soil mechanics surface sampler were returned to earth by Apollo 12 Astronauts Conrad and Bean. A careful surface examination of the scoop has been made both visually and microscopically under a variety of lighting conditions. The blue of the original paint has been changed to a light tan color, but the change is not uniform on all surfaces. In places, the surface exhibits a blotchy appearance, probably due to differential thicknesses of a soil coating, which protected the surface from solar radiation. Although the surface is scratched and abraded, it is not known if this is due to preflight sandpapering or lunar surface operations. No micrometeorite pits were observed. Lunar soil adhered preferentially to (1) painted, (2) Teflon, and (3) metallic surfaces. The strength of the soil adhesion to the paint was in the order of  $10^4$  dynes/cm<sup>2</sup>. Glassy spheres adhered more strongly to the paint than did other lunar granular material.

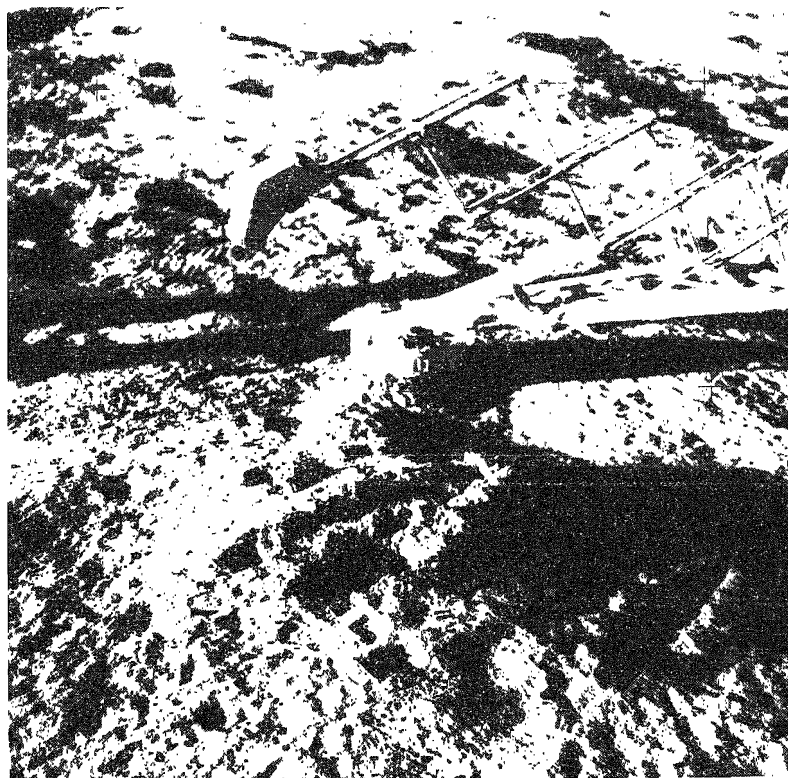
Fig. 1. Apollo 12 view of left side of scoop on moon. NASA AS 12-48-7128.

door. The left side (Fig. 1) shows a shading pattern in which the bottom of the scoop side is lighter. In the preliminary examination of the scoop at the LRL, the right side was heavily coated with soil in the approximate pattern shown in the photograph. This would appear to have been the original lunar soil picked up during surface sampler bearing tests. The shading pattern on the left side is also visible, particularly in the color photographs. The condition of the scoop as it appeared for the examination at HAC (Fig. 2) indicated that most of the soil adhering to the bottom of the right side had been rubbed off, but it can be seen that there is a lighter shading over the area to which it had adhered.

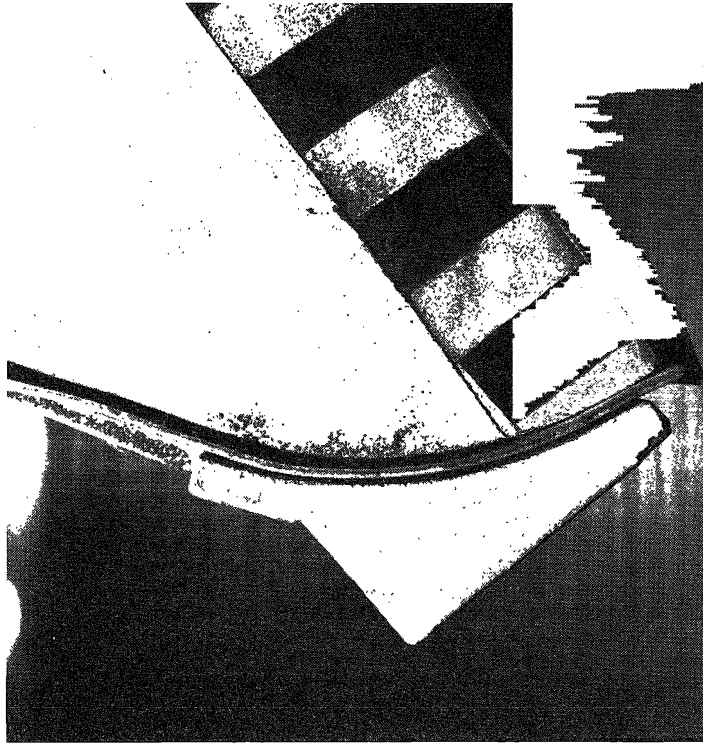
Fig. 2. Laboratory photograph of right side of returned scoop. Width of field = 4.9 cm.

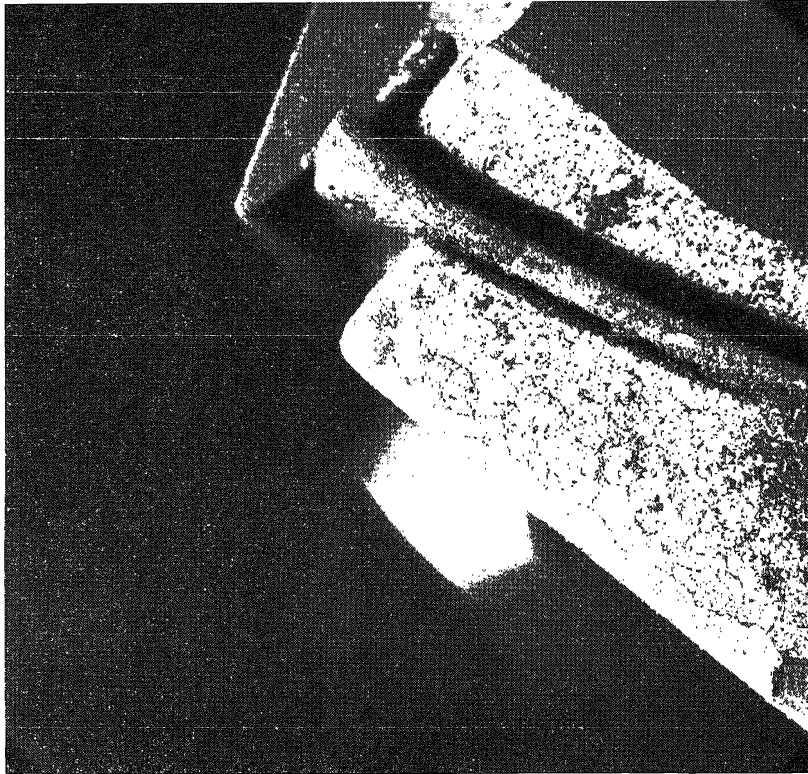
Fig. 3. Left side of returned scoop tip. Width of field = 1.7 cm.

Laboratory and elsewhere, some of the paint around the edge of the scoop door may have been abraded and removed (Fig. 3) since some paint chips appeared in the associated soil. Some of the paint probably was also removed during operations on the lunar surface. It can be seen that the paint is covered with lunar soil particles, including a substantial proportion of small glassy spheres. The irregular bumpy texture of the painted surface is characteristic of the original painted coating. It is not clear if the change in color of the painted surface is due to a surface alteration of the paint or to a thin layer of fine particles on the surface. The color change is not everywhere uniform, and it seems to depend on the degree to which the surface was exposed to solar radiation. On the sides and top of the scoop, light tan blotchy patterns can be seen. In places, these patterns can be correlated with a protective covering of lunar soil apparent both in some of the original Surveyor III pictures and in the astronaut photographs (Fig. 1). The most pronounced color difference between the terrestrial and returned scoops is apparent in the ultraviolet pictures (SCOTT and ZUCKERMAN, 1971). These observations are more consistent with a color change caused by solar radiation rather than a change resulting from a thin soil coating. It is not known why general gradational differences in the degree of the color change exist on apparently uniformly exposed sides of the scoop. It is possible that these are due to changes from place to place in the scoop paint thickness or composition, or may be due to the presence on the moon of differing thicknesses of dust coatings resulting from lunar surface operations. A further possibility is that the abrasion of the paint which took place before launch or during the lunar surface testing resulted

A second item of interest concerning the painted surface is the crazing or cracking of the paint on the sides and base of the scoop door. Polygonal fracture patterns are apparent in Fig. 3. This portion of the scoop was made of a glass fiber-impregnated resin coated with the standard paint. The fracture pattern does not appear on the painted metallic surfaces of the rest of the scoop, and may therefore be related to the different thermal expansion characteristics of the paint, the resin, and the metal. It is also possible that radiation damage to the paint could have resulted in volume changes of the paint. In this case, the appearance of fracture patterns on the scoop door would be related to either the different thickness of the paint or different nature of bonding of the paint to that surface as compared with the other metallic surfaces. The chipping of the paint from the scoop door tips indicates that the bonding between the paint and the resin was weaker there than elsewhere. A careful study of the Surveyor III television pictures was inconclusive in regard to the presence of chipping or flaking at these points during the lunar surface operations in 1967. Observations during handling of the returned surface sampler indicate that the paint at the corners chips quite easily. Chips of paint were observed in the lunar soil which was collected from the inside and outside of the scoop.

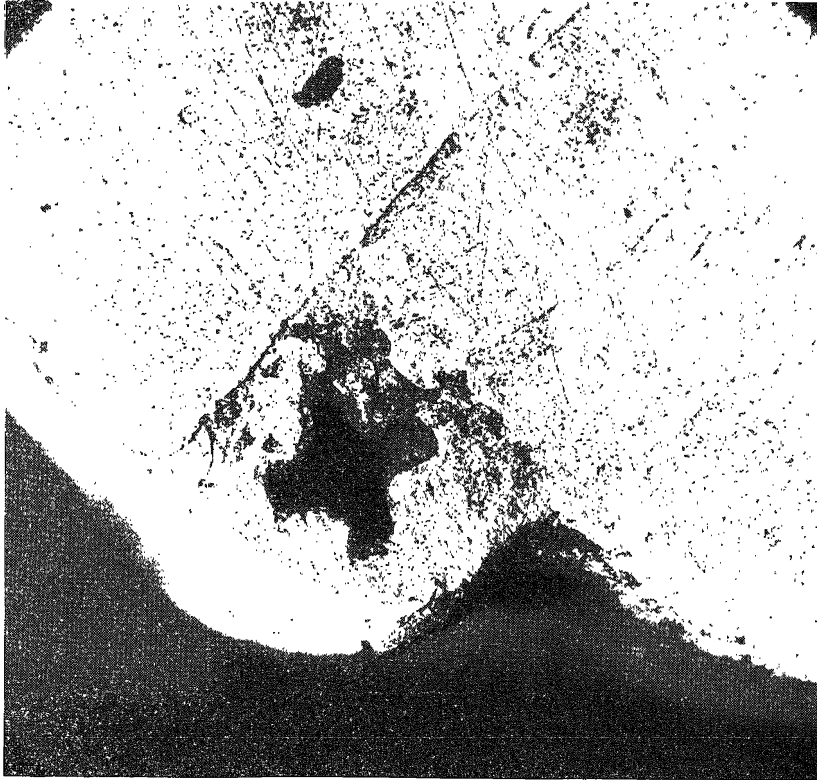
Fig. 4. Screw head in gear box of returned scoop. Width of field = 1.7 cm.

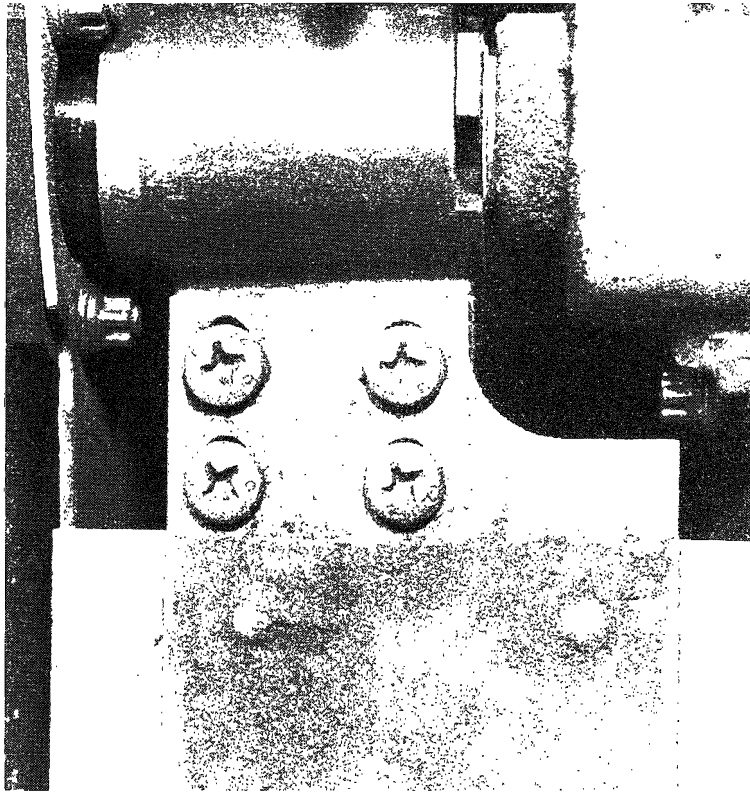
Fig. 6. Door of returned scoop. Width of field = 1.7 cm.
