The 1356 Basel earthquake: an interdisciplinary revision

SUMMARY

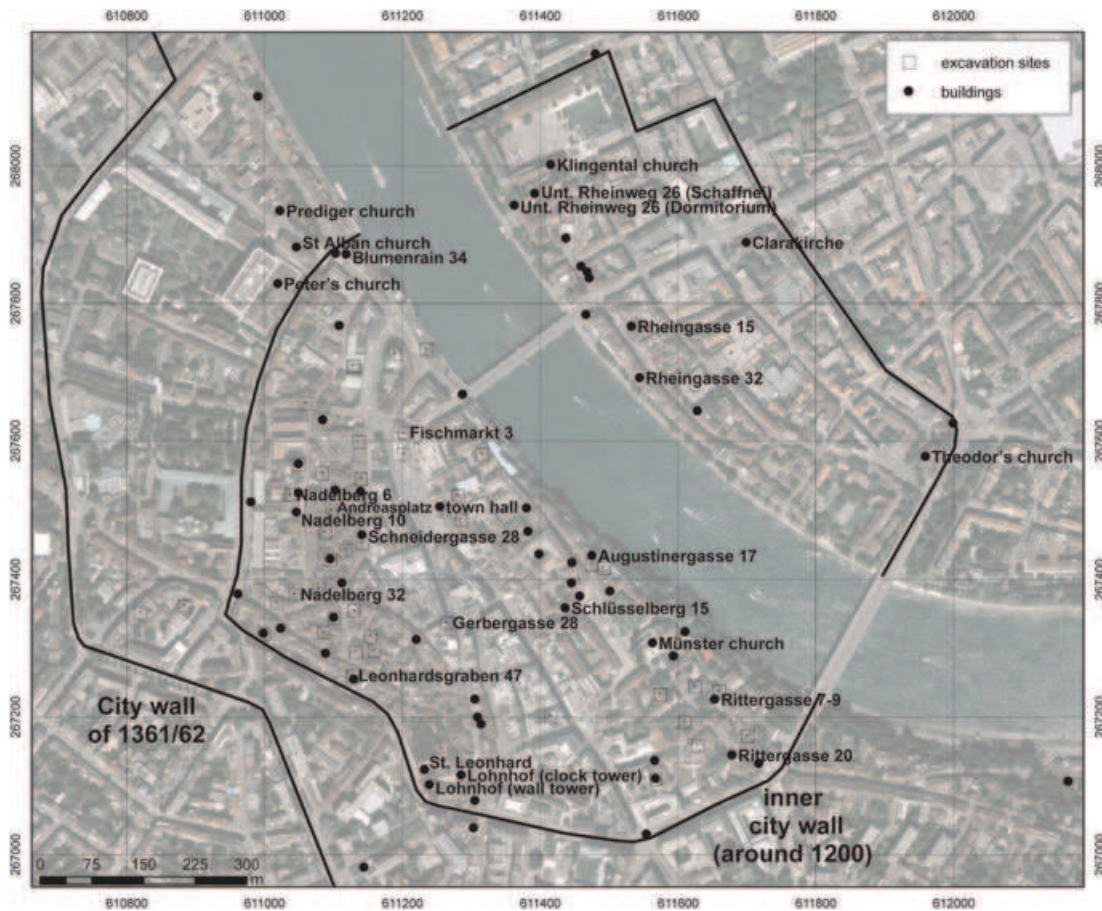
Figure 5. Location of the sites in Basel, for which archaeological data related to the 1356 earthquake exist (circle: building; squares: excavation sites). All indicated locations are given. Klein-Basel is the part of the city north of the Rhine river; Gross-Basel is the part south of the river Rhine. St. Alban Vorstadt is a quarter of the city of Basel around St. Alban church.

Damage from the 1356 earthquake can be observed in the most significant building of Basel: the ‘Basler Münster’ (Münster church in Fig. 5) or cathedral (possibly the church shown in Fig. 4), and also confirmed by historical documents (e.g. Wackernagel 1856; Sieber 1875). A thorough inspection reveals evidence of earthquake damage at different locations in the masonry. Reconstruction seams are visible in the medieval fronts of both west towers: of the original five towers, these were the only ones to be rebuilt. Of the former east towers that once flanked the chancel, only some orphan cornerstones protrude from the upper parts of the walls. Strong distortions are visible in the aisle pillars in the area of the crossing. The late Romanesque aisle vaults survived the event but the nave vault had to be reconstructed.

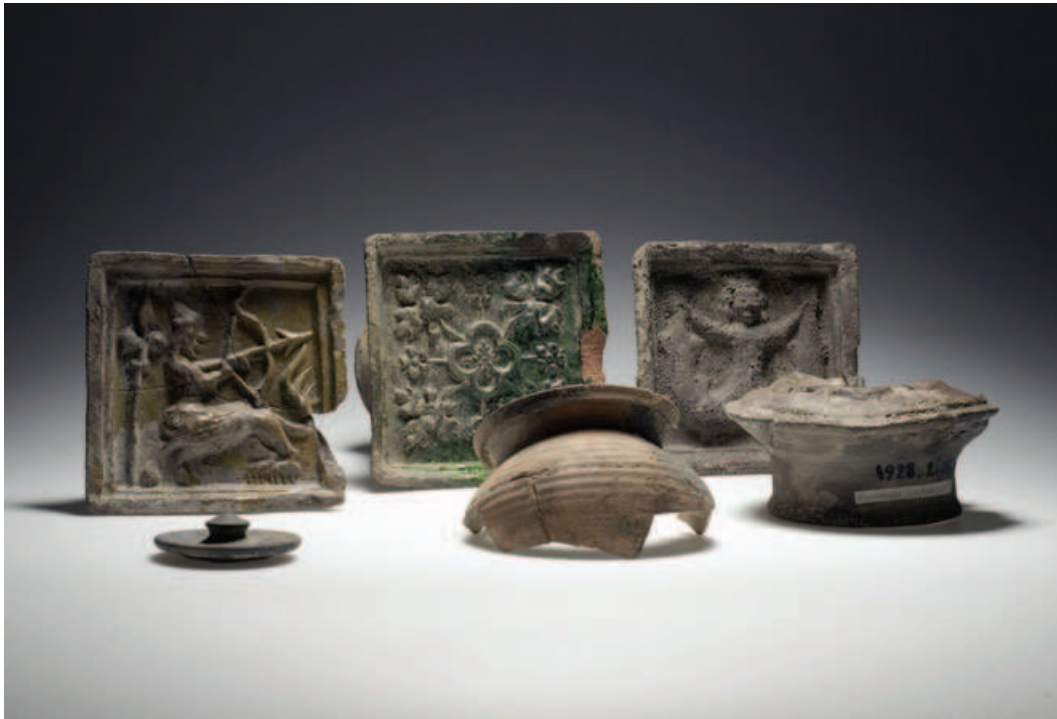
Figure 6. Selection of objects found in a debris layer at Fischmarkt 3 (Photo: Philippe Saurbeck). These date to the second quarter of the 14th century. The stove tiles and other findings show remarkable traces of fire. This might result from the fire following the 1356 earthquake, because this part of the city was not affected by the fires of 1354 and 1377.

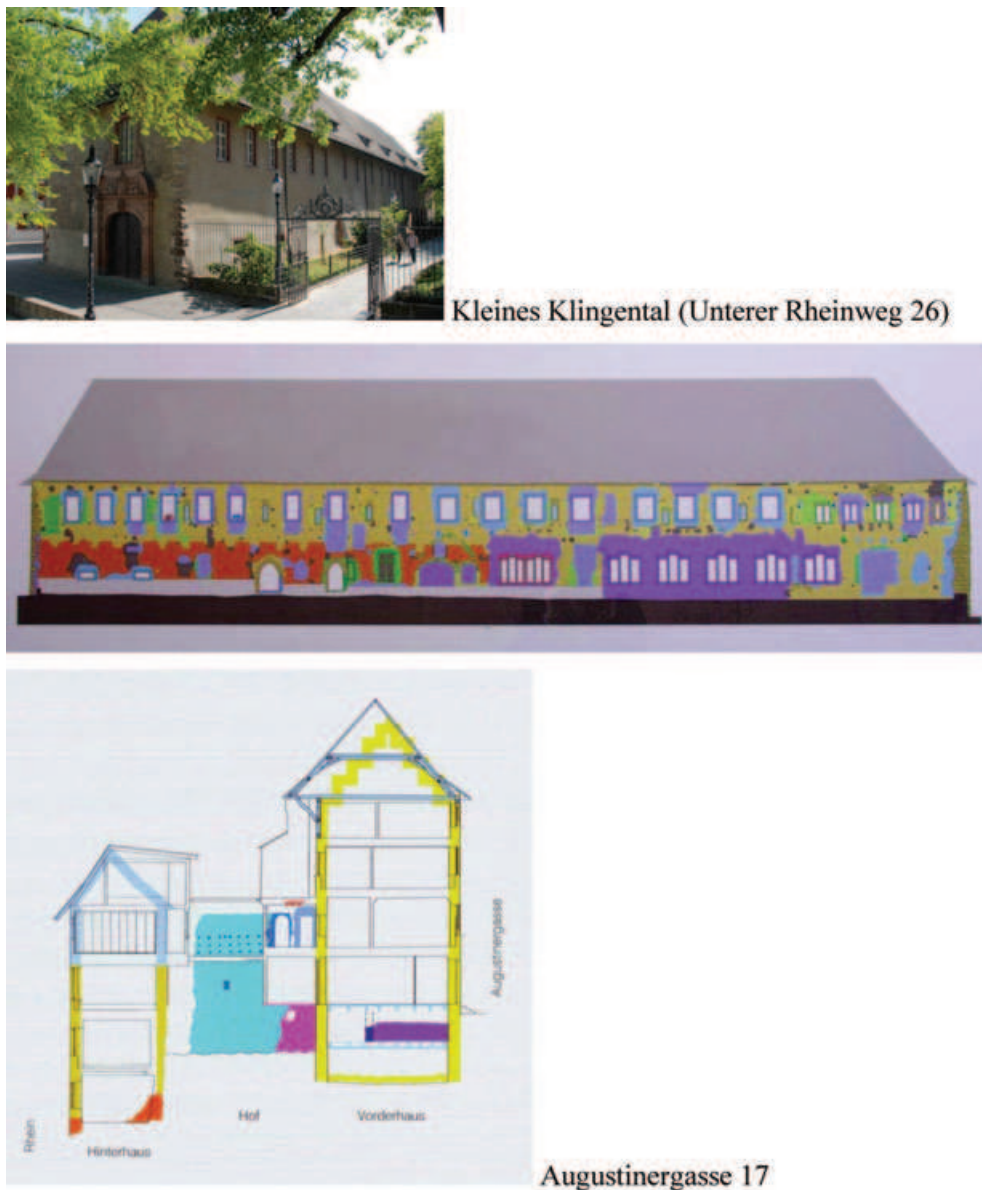
Figure 7. Examples of buildings investigated, indicating the range of vulnerability class and damage grade. **Top:** Archaeological building inventory of 'Kleines Klingental', Unterer Rheinweg 26. It is completely conserved to the top, with dendro-chronological dating for the pre-earthquake period in the roof. **Bottom:** The same for Augustinergasse 17; the yellow walls date to the period after 1356, the foundation (orange, pink, purple) dates to the time before the earthquake (Jaggi 2000; DPF-BS: Bauforschung, Befunddossier 2007). No indication of fire was found. One dendro-chronological dating to the year 1363 is available. For the location of the two buildings, see Figure 5.

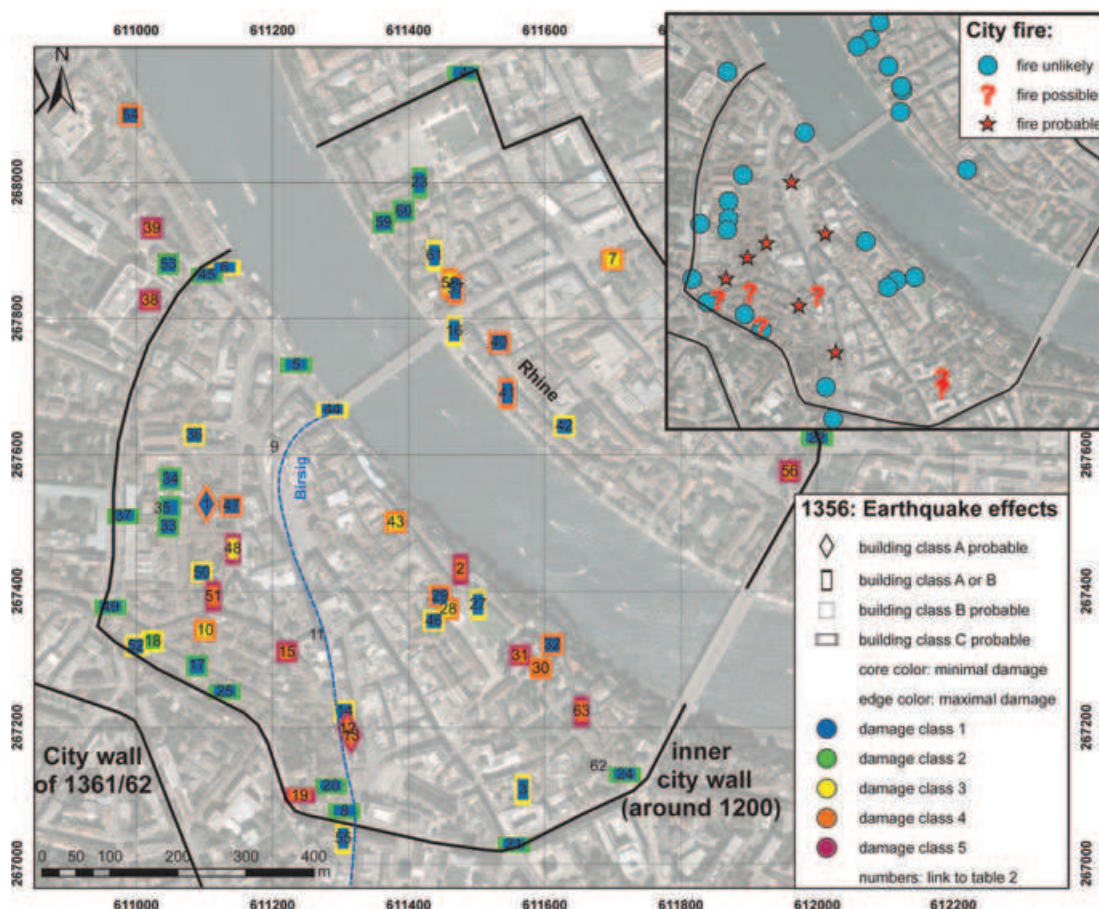
Figure 8. (a) Overview of the assessed buildings in Basel, including the most probable vulnerability class and the range of possible direct earthquake damage. Damage is concentrated in areas with low building quality along the rivers Birsig and Rhine. Numbers refer to the numbers in Table 2; numbers without color-coding are given when the building class could not be applied. Nr. 26 is outside the area shown in the figure. (b) (inset) Buildings that show traces of fire in the stonework and plaster. Damage due to fire is separated from direct earthquake damage for EMS intensity assignment. With this data set, we can roughly locate the city fire that several historical sources traced to the earthquake.

As expected, damage shows a clear relation to building quality. Buildings of vulnerability classes B and C generally survived better. More vulnerable buildings with higher damage are characteristic in the 'Birsig' valley, a lower income area supposedly devastated by a fire following the earthquake. Unsurprisingly, the geographical

separation of Basel's income classes is reflected in the damage distribution.

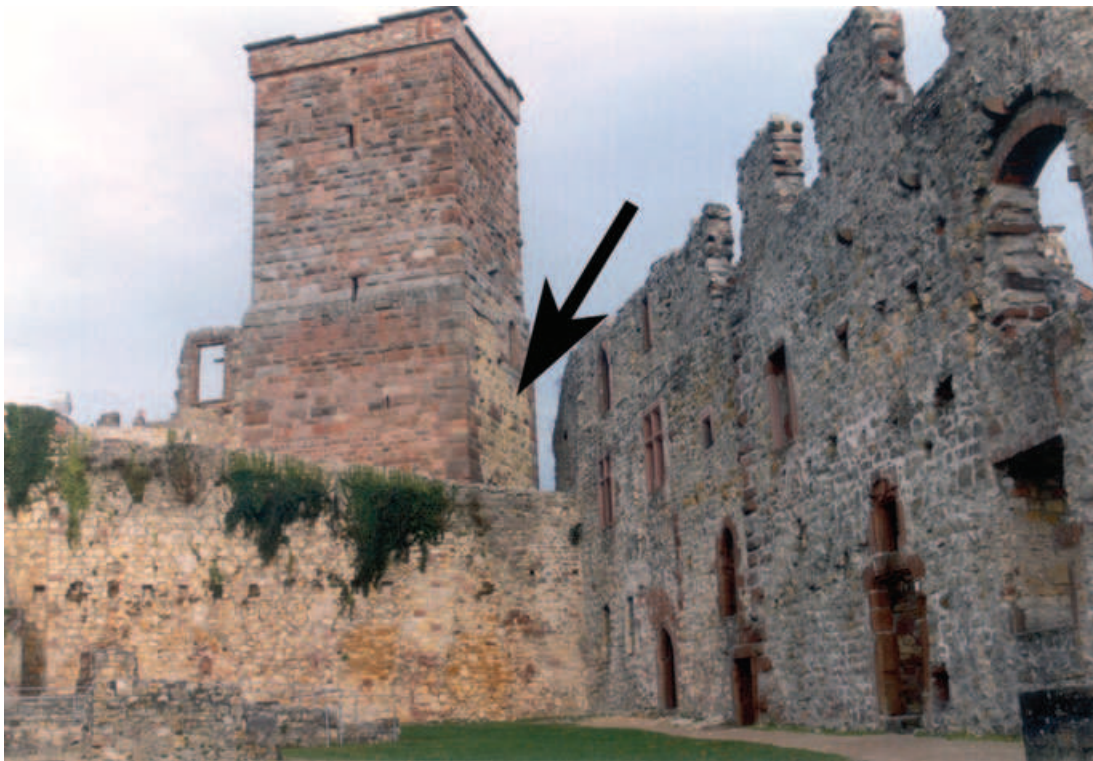
Figure 9. Picture of Rötteln Castle close to Lörrach (Schomann, unpublished data). See noticeable repairs on its eastern side (see arrow). Documents providing reasons for the repair do not exist.

Construction work at ‘Röt(t)eln’ Castle near Kaiserstuhl (AG) reports high costs in the year 1359. The available record does not, however, justify strongly attributing such activities to seismic damage (GLA: Ms. 5 Conv. 548. Perg. REX II 5462, 5453). Thus, it has not been integrated in our assignment sample. For the same reason, we omit alleged devastation reported for the town Zofingen (AG) in ‘Frikart’s chronicle’ (Frikart 1811), as well as archaeological indications for quake damage to the bell towers in Rodersdorf (SO) (Loertscher 1957). Both hints offer no direct indication of whether they can be linked to the event. They consequently have not been assigned for our purposes.

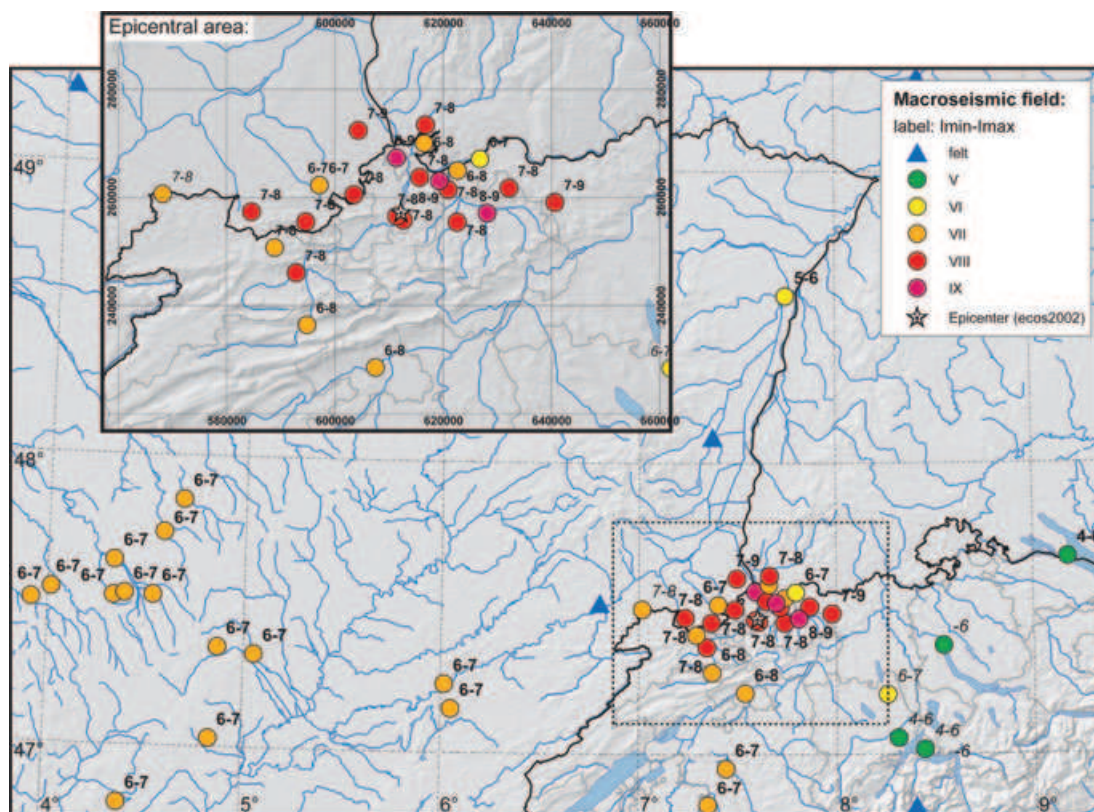
Figure 10. Macroseismic field of the 1356 earthquake. The color of the point describes the intensity estimate; numbers depict the possible range from minimum to maximum probable intensity. Italic numbers relate to intensity estimates where palaeoseismological investigations were used.

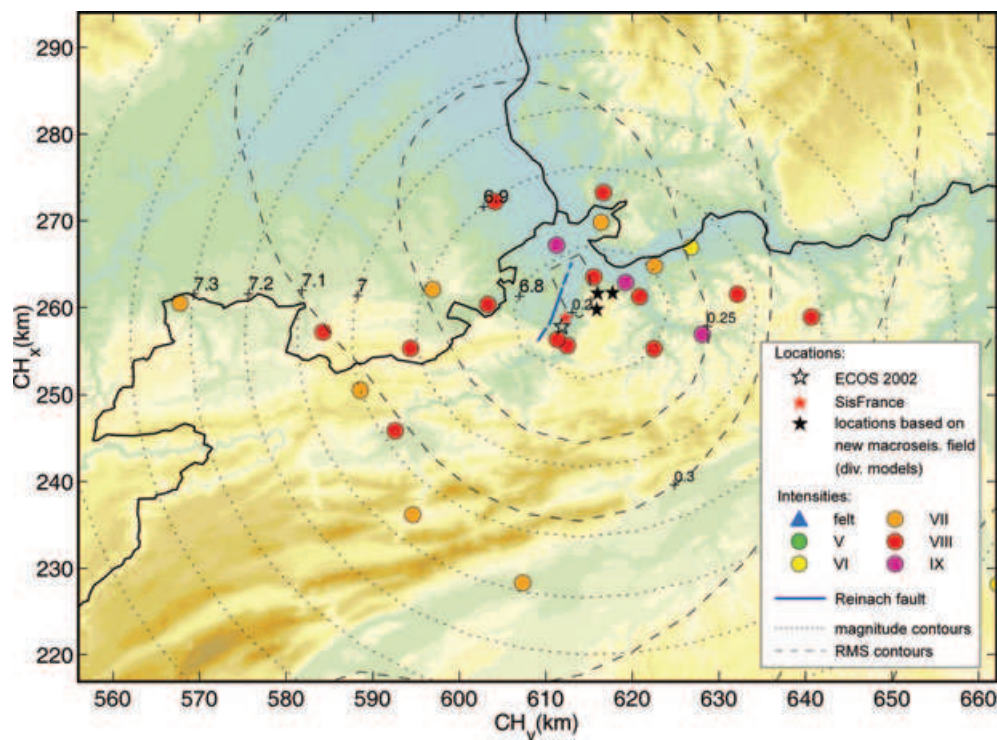
Figure 11. Assessment of the epicenter location and magnitude of the Basel earthquake from macroseismic data points. The epicenter location provided by the earthquake catalog of Switzerland (ECOS) is given as an open star; the new locations obtained with the different sub-data sets are given as filled stars. For one example (data set b), the magnitude contours show the best fitting magnitude at each point (dotted lines), whereas the rms (Mm) contours (dashed lines) show for each point the misfit to the macroseismic field. The epicenter location of SisFrance (Bureau de recherches géologiques et minières 2007), preferred by Bakun & Scotti (2006), is given as a black star.
